Kaiwaiwai Constructed Wetland and water quality – June 2015

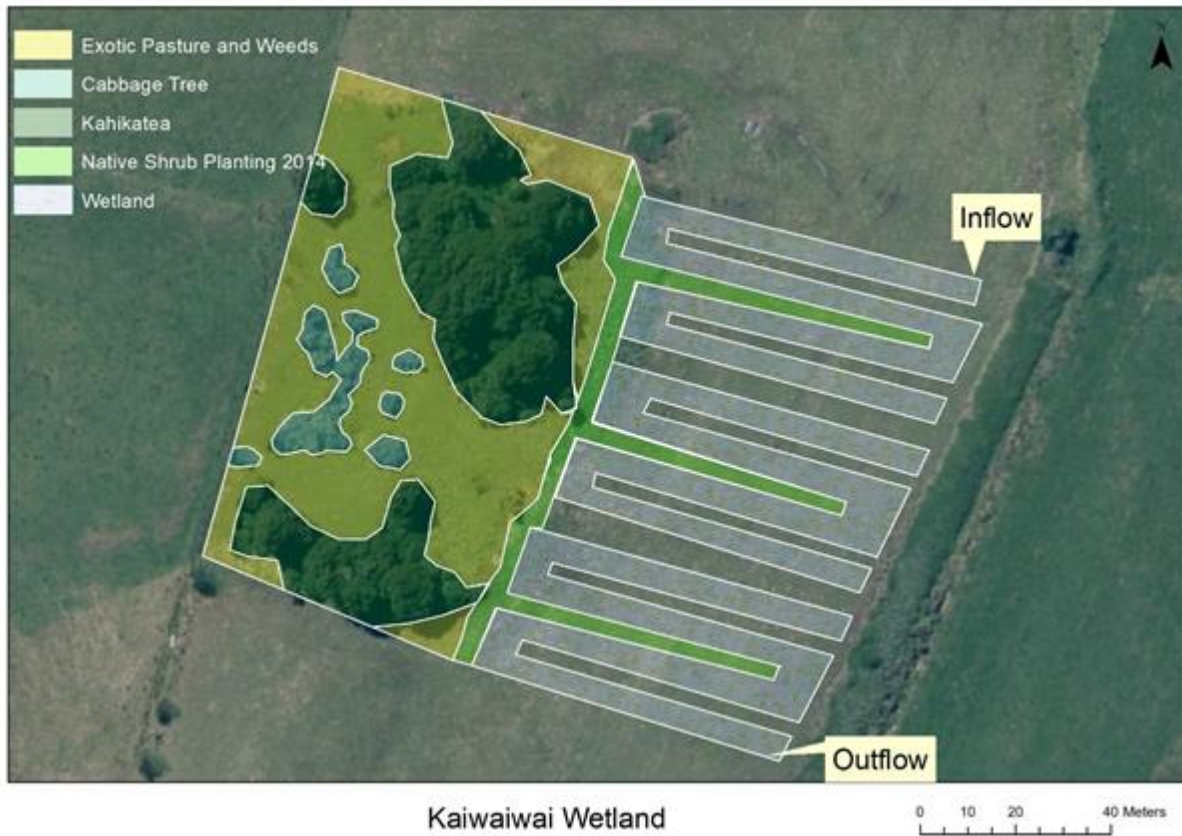
Figure 1 Map showing location remnant bush and design of wetland with entry and exit points.

The design is unique in that the area actually comprises of three separate wetlands providing a serpentine flow path of water down 6m wide bays. These bays run back and forth across the area to slow down water flow, maximise residence time and water treatment. The wetland is well vegetated to give good dispersion and even flow through the majority of wetland and minimise channelisation or dead-zones. After passing through the wetland the treated water will re-join the original drain. The area is fenced to exclude livestock. A special feature of this project is the restoration and protection of a large Kahikatea and Totara which was overgrown with blackberry. Figure 1 shows the layout of the wetland.
